**AGENDA
REGULAR BOARD MEETING OF THE
SAN ELIJO JOINT POWERS AUTHORITY
MARCH 15, 2022 AT 8:30 A.M.**

**Marine Taxonomic Services Ltd. 2022. San Elijo Ocean Outfall 2021 Inspection
Report. Prepared for San Elijo Joint Powers Authority. February 22, 2022.**

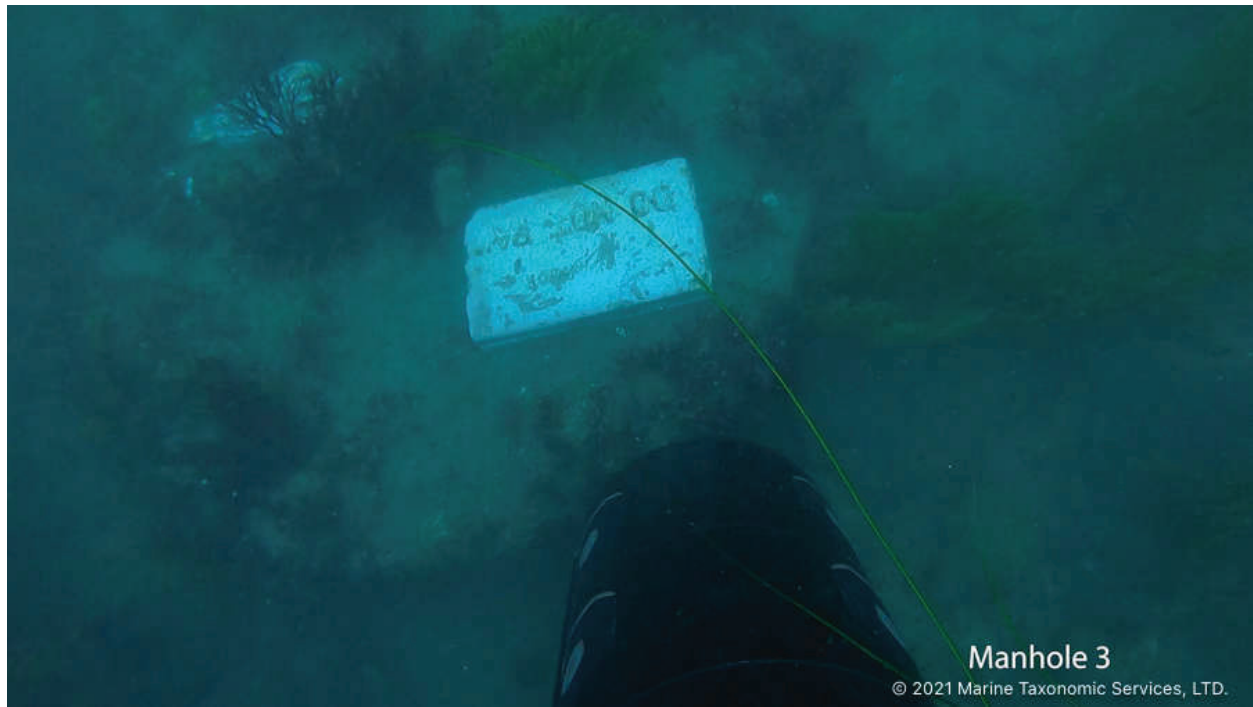
Visual inspection of the portholes 1-3 revealed the portholes and associated zinc anodes to be in fair to good condition (Figure 3). There were no signs of concrete spalling, leaks, or fractures. Cathodic protection (CP) readings on zinc anodes were also conducted and the anodes were cleaned of oxidized material and fouling organisms. Data from the 2021 survey, as well as for CP readings from the previous three years of surveys, are presented in Table 1. All readings indicate that porthole covers are currently being protected by the anodes.

All of the exposed portholes were estimated to have a 0.1-inch-thick corrosion layer. Porthole 1 had a 2-inch-thick biofouling layer. Porthole 2 and porthole 3 had a 1-inch and 0.5-inch-thick biofouling layer, respectively. All exposed portholes are shown in the video data provided with this report. Locations where shell hash obscures portholes 4 and 5 can also be seen in the video.

Figure 3. Porthole 3 cover with zinc anode with approximately 50% remaining life expectancy.
