## Ocean Outfall Assessment

# Outfall Integrity Report

FINAL / April 2024

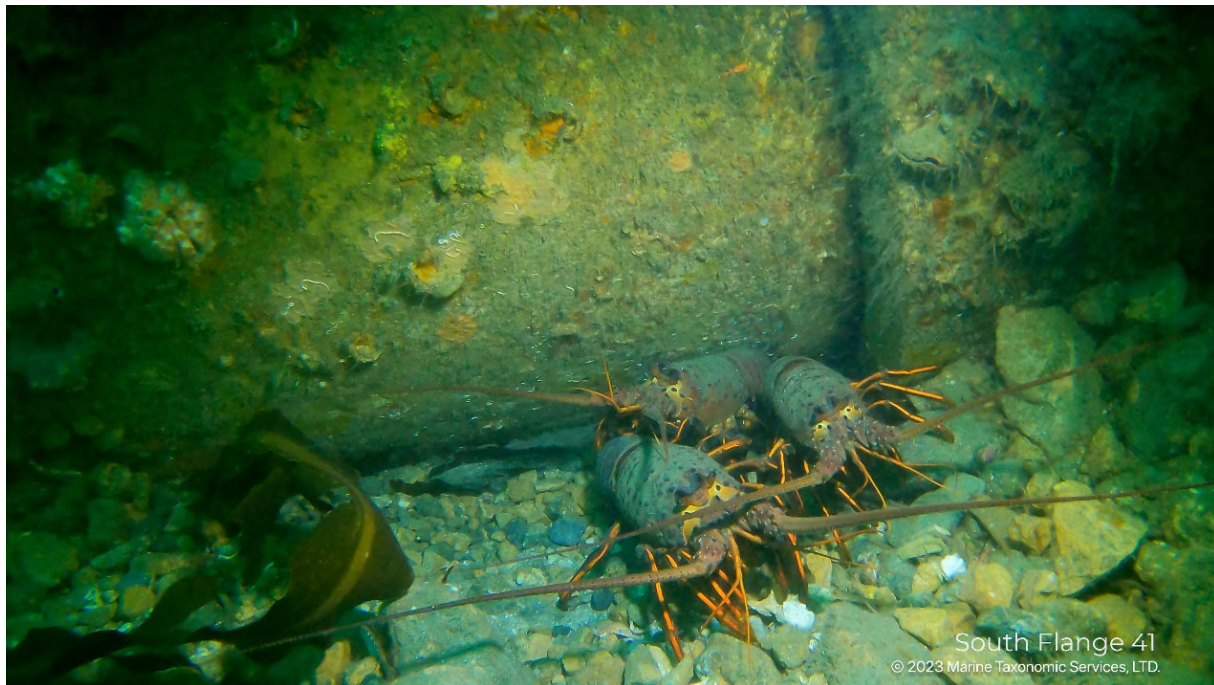
Figure 4 Local Spiny Lobsters

Growth of marine plants and animals on artificial surfaces is a common occurrence when they are submerged for an extended period of time. Although some evidence of marine growth was found, it was minimal and not believed to affect the outfall piping. During MTS' inspection, numerous Spiny Lobsters, shown in Figure 4, were observed in holes beneath the outfall in the deep section that is not ballasted. The amount of material excavated by the lobsters is minimal compared to the total area of seafloor the pipeline rests on, however the slow movement of material over time could reduce the contact area with the seafloor and increase the stress on the pipeline.

There was one notable observation with regards to spiny lobster. Spiny lobster abundance has increased with greater numbers of lobster and larger individuals observed since the SEOO has been included in the Swamis State Marine Conservation Area. During the current survey, numerous lobsters were observed in holes beneath the outfall in the deep section that is not ballasted. While the amount of material excavated is minimal compared to the total area of seafloor the pipeline rests on, the slow movement of material by lobster over time could reduce the contact area with the seafloor and increase the stress on the pipeline.

- Continue to monitor the presence of “lobster burrows” and possible loss of pipeline bedding material during future surveys.
- Perform replacements of anodes as noted above.

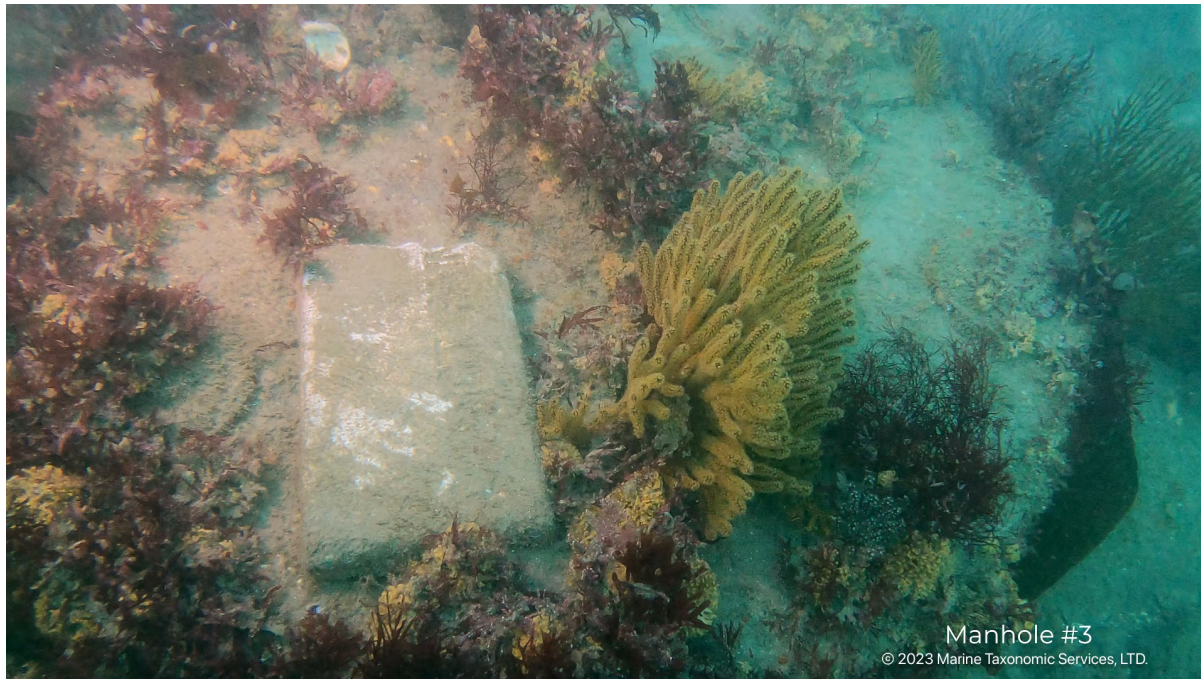
Figure 5 [Manhole No. 3](#)

Portholes 1 through 3 were visually inspected, while Portholes 4 and 5 could not be excavated from the overlying shell hash and could not be inspected. The portholes and anodes that were inspected were

found to be in fair to good condition. Cathodic protection readings were taken, all having an estimated remaining anode mass of 60 percent. The portholes showed no signs of spalling, leaks, or fractures. Figure 5 shows Porthole 3 and surrounding rock ballast with marine growth.

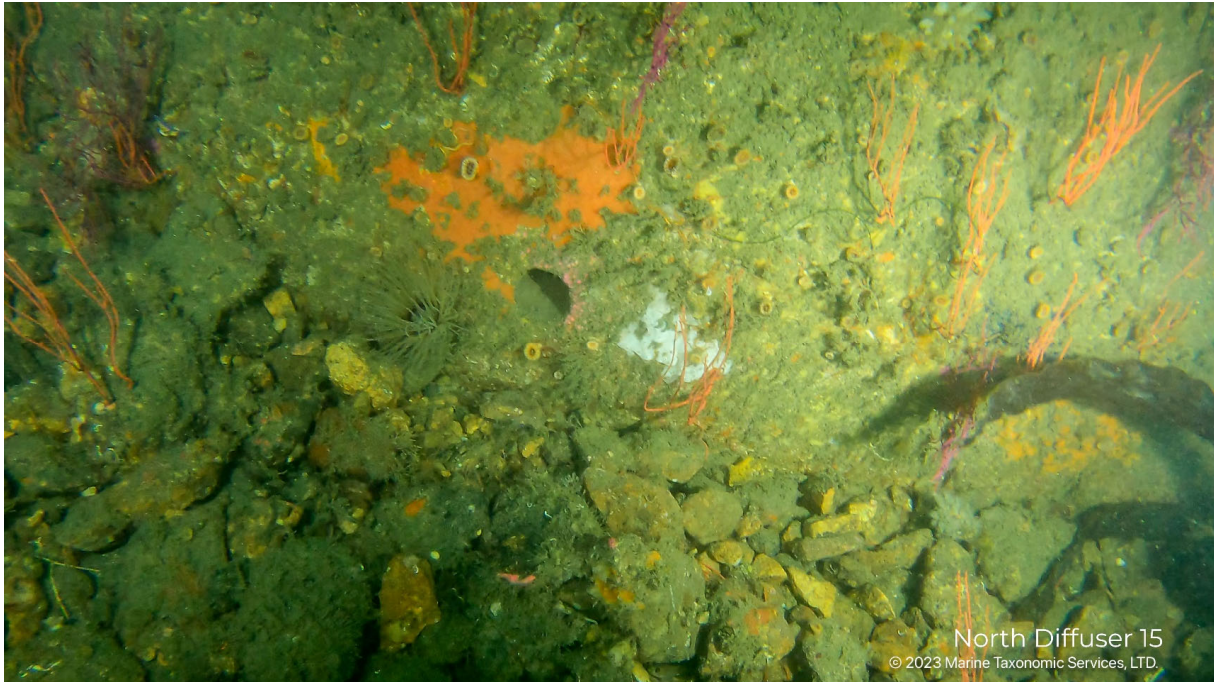
Figure 6 Clear Diffuser Port

The final diffuser section is composed of two hundred 2-inch nominal diameter diffuser ports for effluent discharge. Diffuser holes will often become partially clogged due to growth of marine life, also known as biofouling. Figure 6 shows an open and clear diffuser port. All diffusers were observed to be free of biofouling and properly flowing.

Divers visually observed all 200 diffuser ports along the diffuser section of the outfall pipe. The presence of biofouling or any kind of notable obstruction was not observed. Diffuser ports 1 on the northern and southern side of the end cap structure were not flowing, however this is the typical condition for these diffuser ports and was not considered to be blocked by any form of obstruction. These “ports” are in the end structure and are not drilled all the way through to the pipeline. All other diffuser ports appeared to be in proper working function with observable flow coming out of the diffuser ports. Each of the diffuser ports in shown in the video survey results included with the submission of this report.

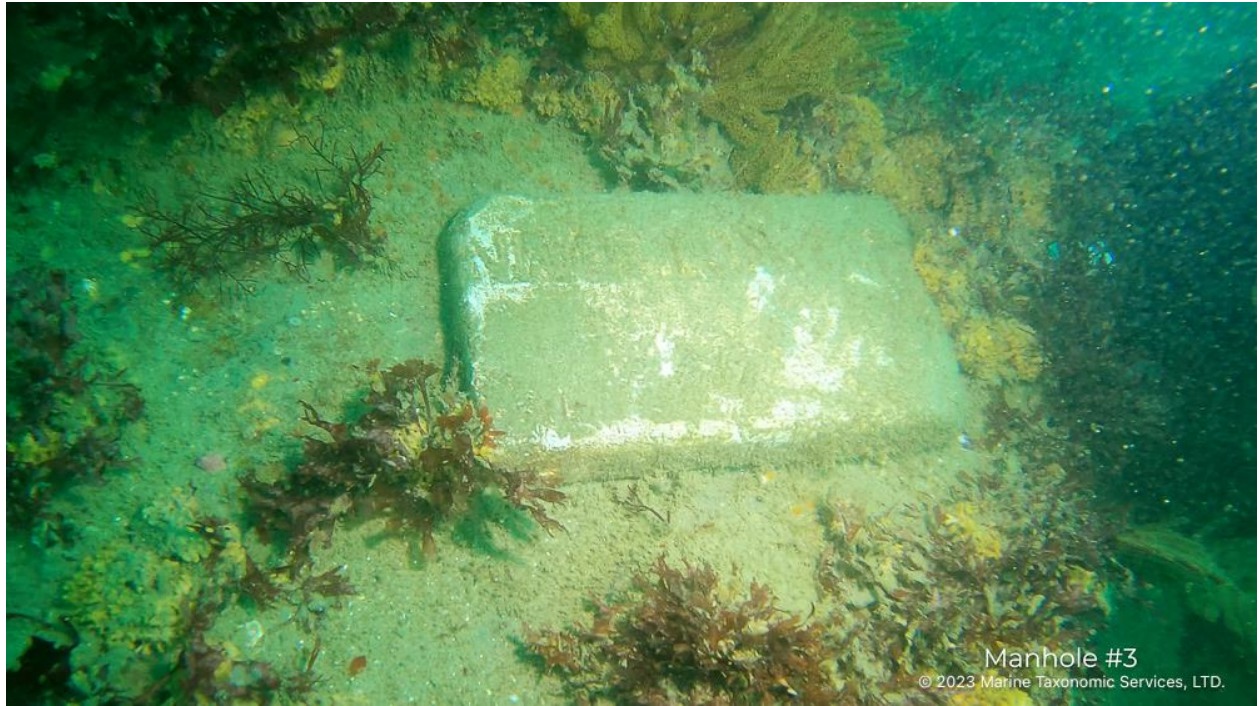
Visual inspection of the portholes 1-3 revealed the portholes and associated zinc anodes to be in fair to good condition (Figure 3). There were no signs of concrete spalling, leaks, or fractures. Cathodic protection (CP) readings on zinc anodes were also conducted and the anodes were cleaned of oxidized material and fouling organisms. Data from the 2023 survey, as well as for CP readings from the previous three years of surveys, are presented in Table 1. All readings indicate that porthole covers are currently being protected by the anodes.

All of the exposed portholes were estimated to have a 0.1-inch-thick corrosion layer. Porthole 1 had a 2-inch-thick biofouling layer. Porthole 2 and porthole 3 had a 1-inch and 0.5-inch-thick biofouling layer, respectively. All exposed portholes are shown in the video data provided with this report. Locations where shell hash obscures portholes 4 and 5 can also be seen in the video.

**Figure 3. Porthole 3 cover with zinc anode with approximately 50% remaining life expectancy.**

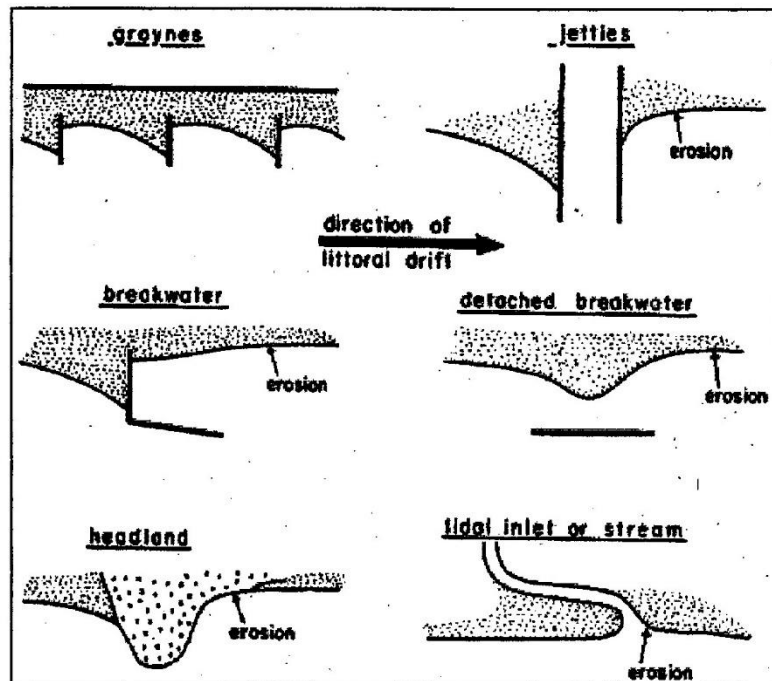
Scour around an outfall can also be noted on a larger scale as differences in bottom elevation of the nearfield sediment distribution around a pipe and ballast pile. On the up-current side of the pipe, the seawater slows down as it approaches the ballast pile and loses some of its energy. As a result, its ability to transport sediment is reduced, thus causing deposition on the up-current side of the pipe. As fluid passes over the pipe and ballast pile it gains energy but not enough to displace correctly designed ballast. As the seawater leaves the down-current edge of the ballast pile, its energy is increased because of the turbulence around the ballast pile and a return to non-deflected flow. This increased energy level enhances the ability to transport sediment. Thus, sediment deposited at the ballast pile is re-suspended and transported away, which results in a lower level of sand on the down-current side. This same phenomenon is typically visible around a jetty where the up-current side experiences buildup of material and the down-current side shows a loss of material.

Figure 5-2 Deposition and erosion due to interruption of longshore transport

Scour results in the loss of sand around the toe of the ballast pile, around the pipe, and supporting structures where no ballast exists. Excessive scour can lead to ballast pile setting or collapse and weakened support foundation, which eventually may result in unsupported spans of pipe.
