MARINE TAXONOMIC SERVICES, LTD.

San Elijo Ocean Outfall 2021 Inspection Report

February 22, 2022

San Elijo Joint Powers Authority
2695 Manchester Ave.
Cardiff, CA 92007

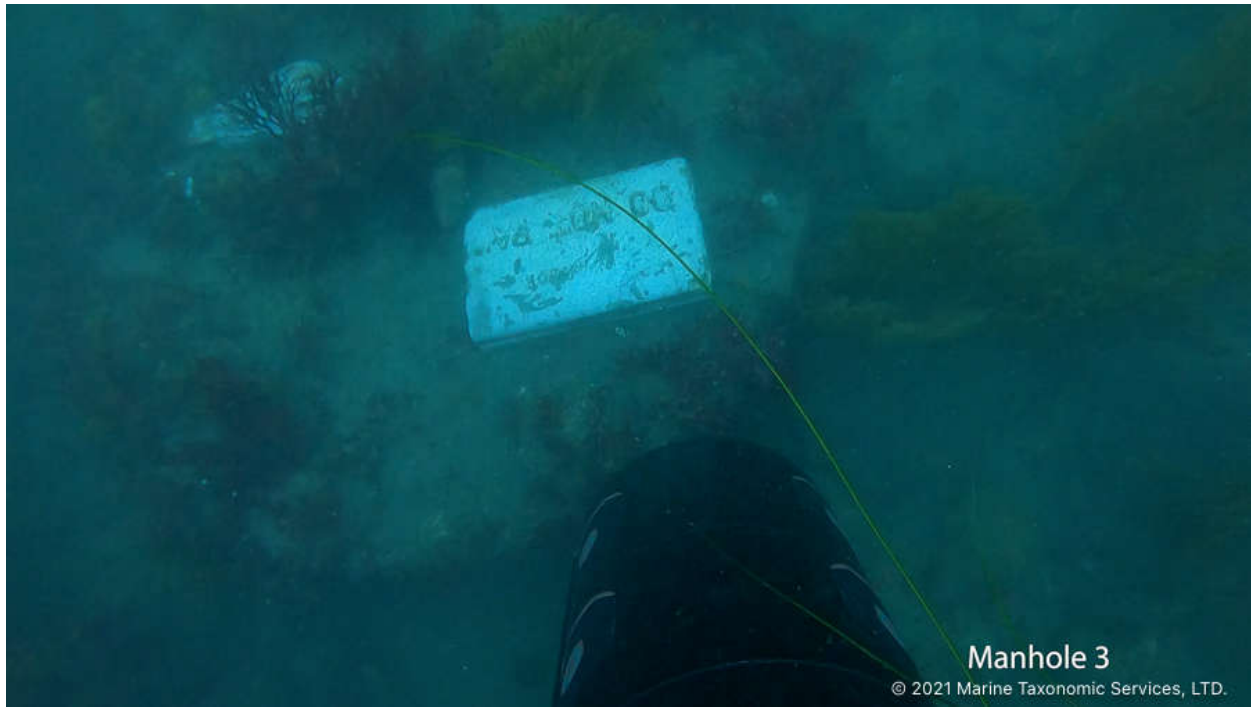
Visual inspection of the portholes 1-3 revealed the portholes and associated zinc anodes to be in fair to good condition (Figure 3). There were no signs of concrete spalling, leaks, or fractures. Cathodic protection (CP) readings on zinc anodes were also conducted and the anodes were cleaned of oxidized material and fouling organisms. Data from the 2021 survey, as well as for CP readings from the previous three years of surveys, are presented in Table 1. All readings indicate that porthole covers are currently being protected by the anodes.

All of the exposed portholes were estimated to have a 0.1-inch-thick corrosion layer. Porthole 1 had a 2-inch-thick biofouling layer. Porthole 2 and porthole 3 had a 1-inch and 0.5-inch-thick biofouling layer, respectively. All exposed portholes are shown in the video data provided with this report. Locations where shell hash obscures portholes 4 and 5 can also be seen in the video.

Figure 3. Porthole 3 cover with zinc anode with approximately 50% remaining life expectancy.
